# CAERNARFON BAR BUOYS - Updated 04.03.2010

## IMPORTANT NOTICE TO MARINERS

## CAERNARFON BAR CHANNEL

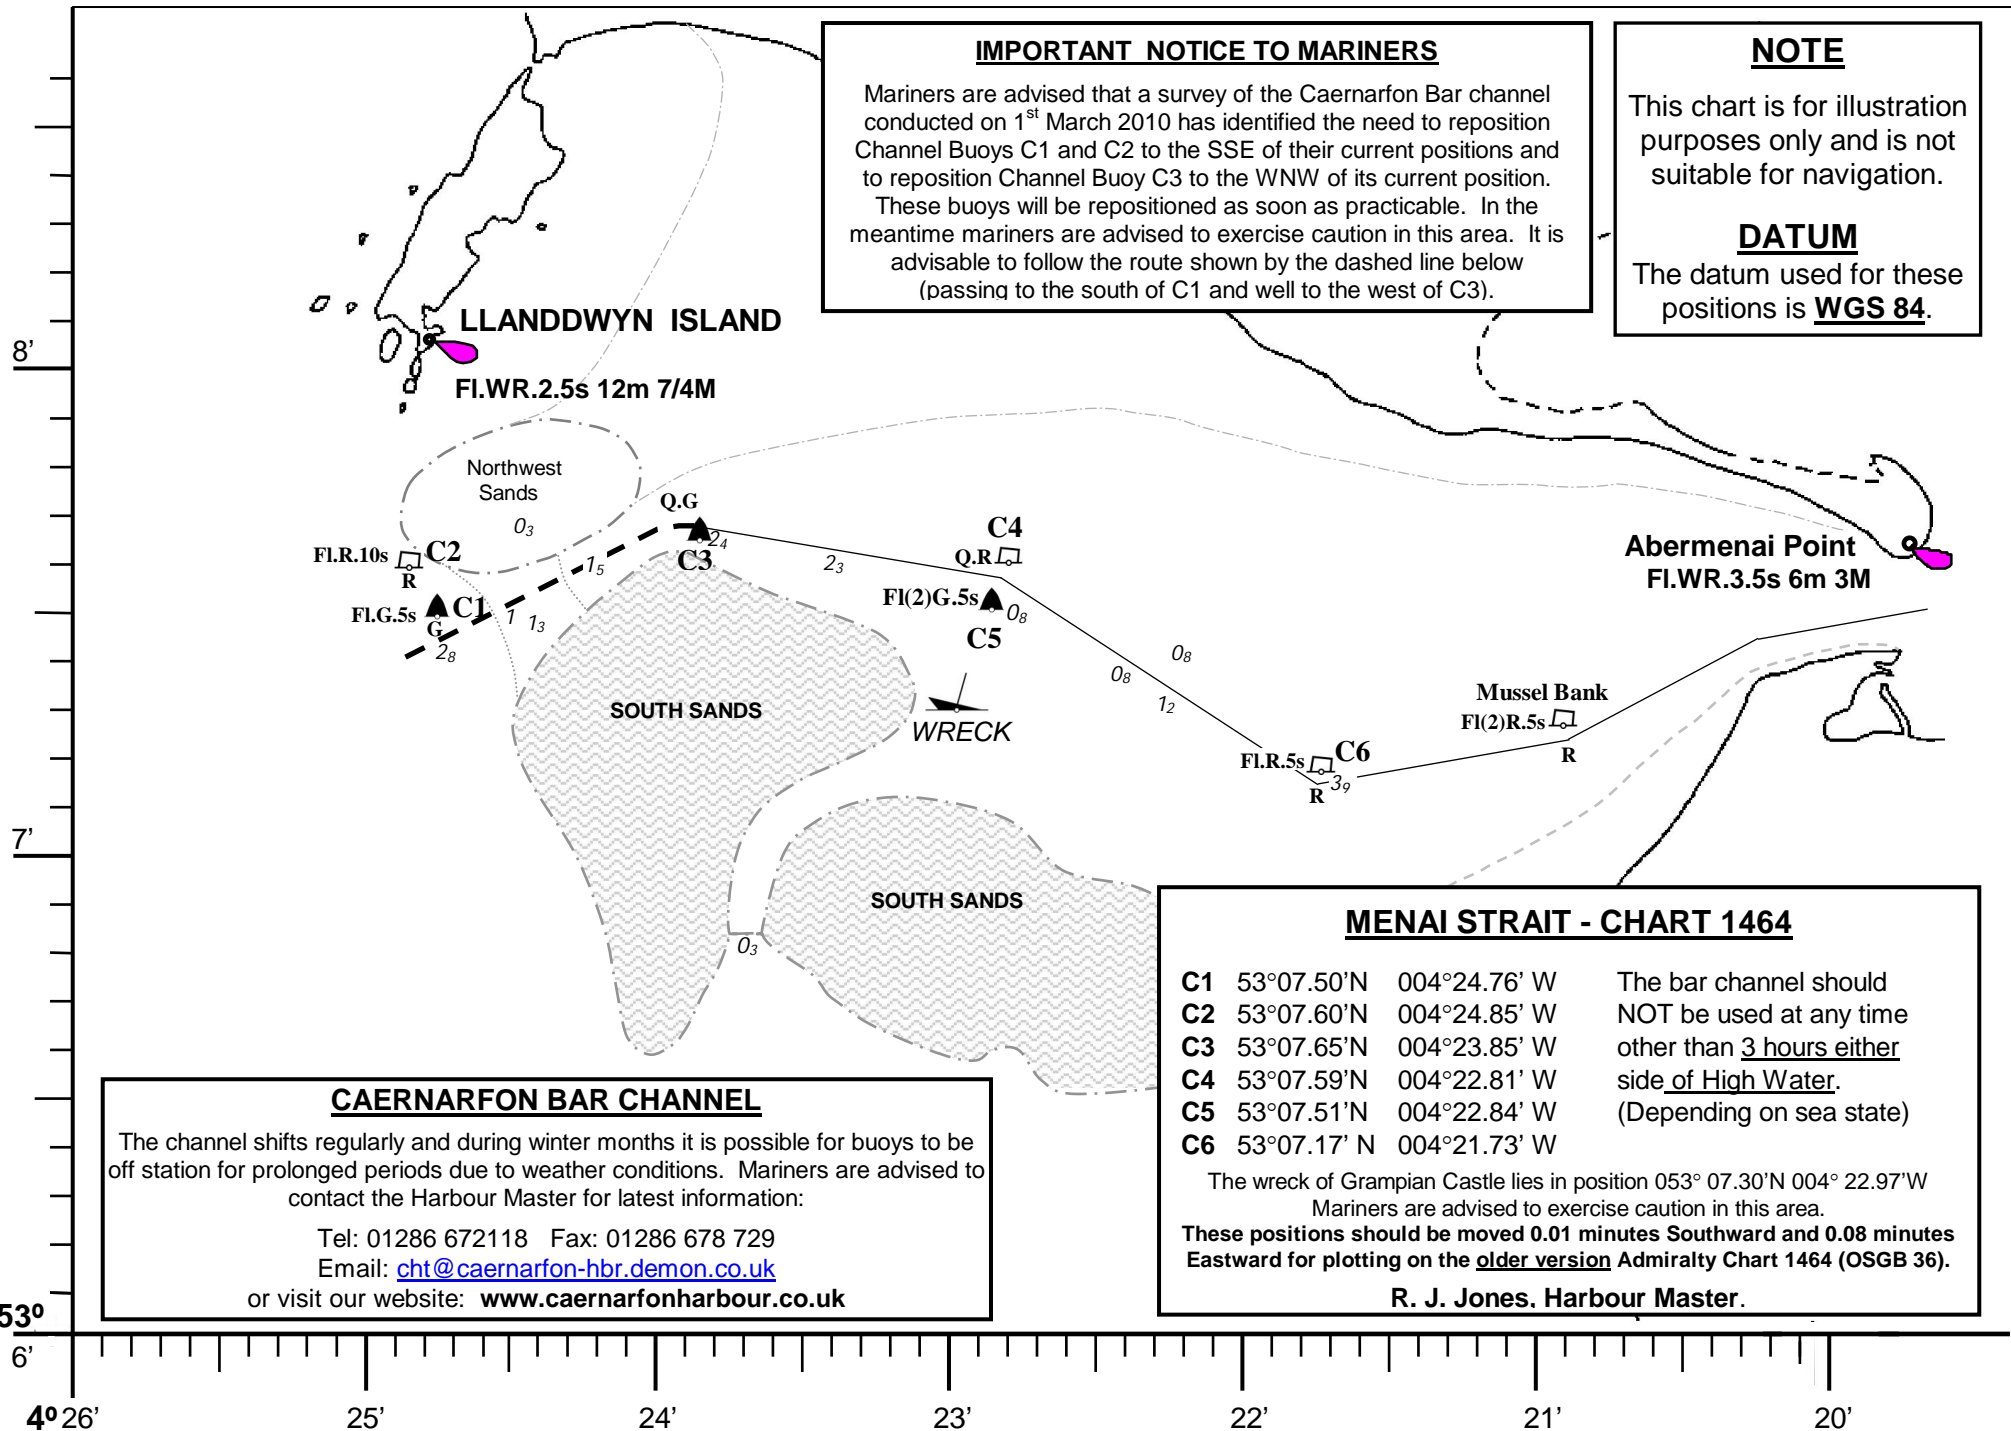
Mariners are advised that a survey of the Caernarfon Bar channel conducted on 1<sup>st</sup> March 2010 has identified the need to reposition Channel Buoys C1 and C2 to the SSE of their current positions and to reposition Channel Buoy C3 to the WNW of its current position. These buoys will be repositioned as soon as practicable. In the meantime mariners are advised to exercise caution in this area. It is advisable to follow the route shown by the dashed line below (passing to the south of C1 and well to the west of C3).

<b>C1</b>	53°07.50'N	004°24.76' W	The bar channel should NOT be used at any time other than <u>3 hours</u> either side of <u>High Water</u> . (Depending on sea state)
<b>C2</b>	53°07.60'N	004°24.85' W	
<b>C3</b>	53°07.65'N	004°23.85' W	
<b>C4</b>	53°07.59'N	004°22.81' W	
<b>C5</b>	53°07.51'N	004°22.84' W	
<b>C6</b>	53°07.17' N	004°21.73' W

The wreck of Grampian Castle lies in position 053° 07.30'N 004° 22.97'W. Mariners are advised to exercise caution in this area. These positions should be moved 0.01 minutes Southward and 0.08 minutes Eastward for plotting on the older version Admiralty Chart 1464 (OSGB 36).
